# Consolidated Olive Ridley Sea Turtle Mitigation Action Plan

**DRAFT**

1.2. **Confirmed Olive Ridley Turtle Catches by Seismic Equipment on the TOTAL Operation in Gabon.**

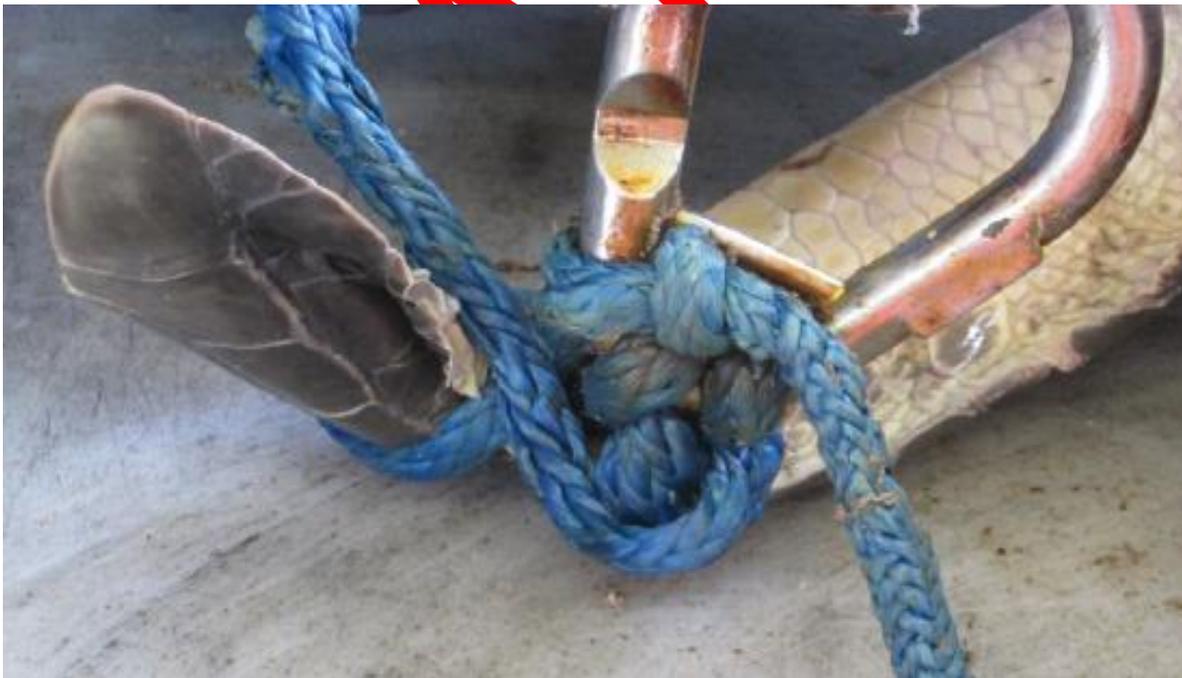
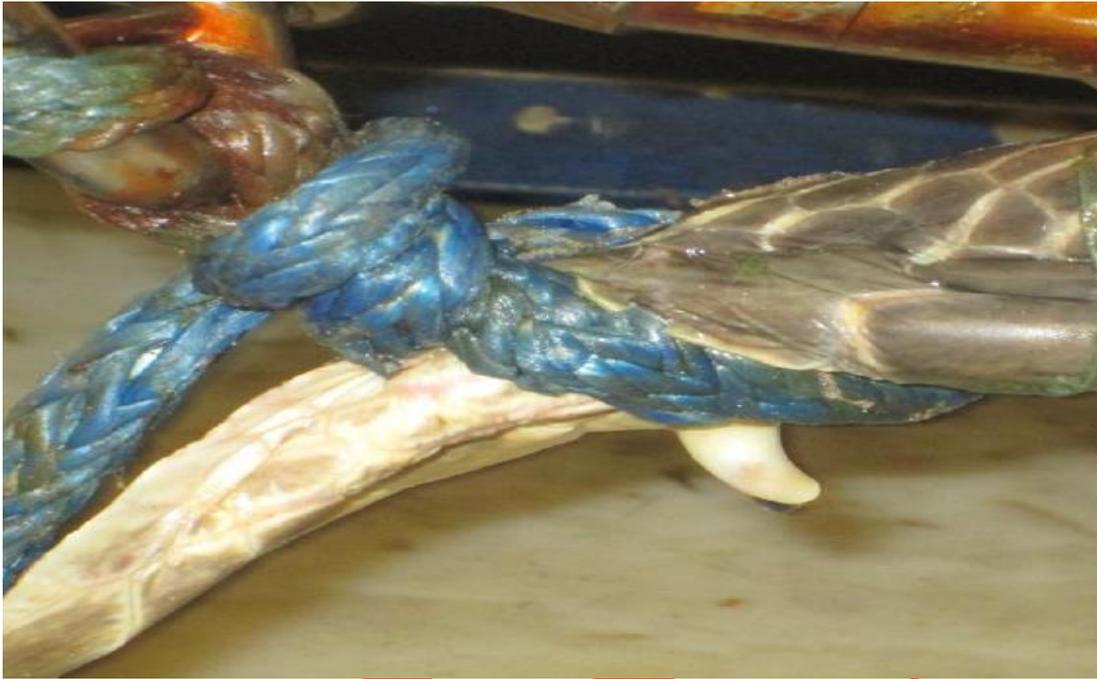
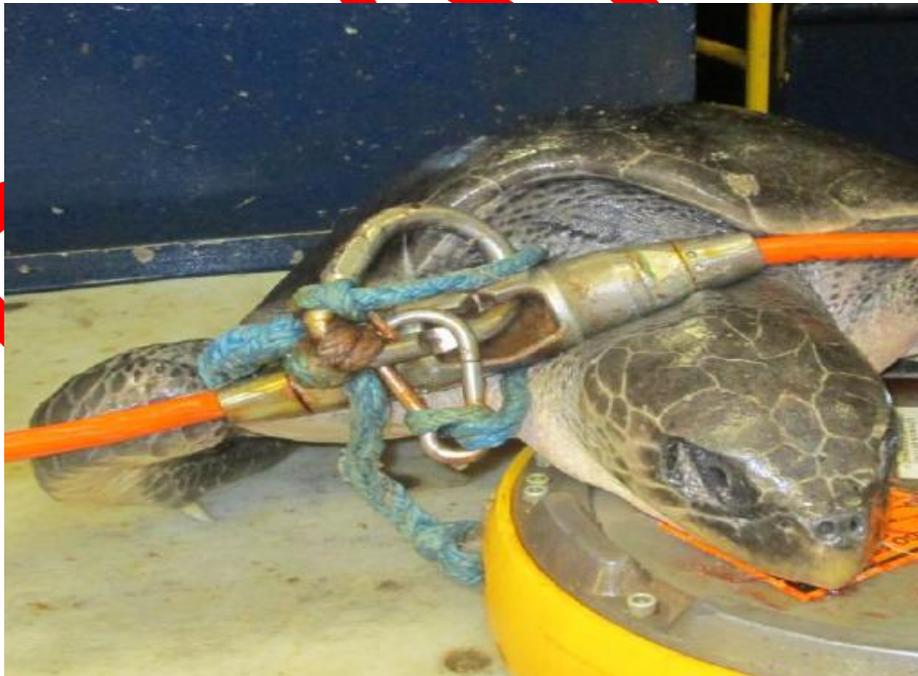
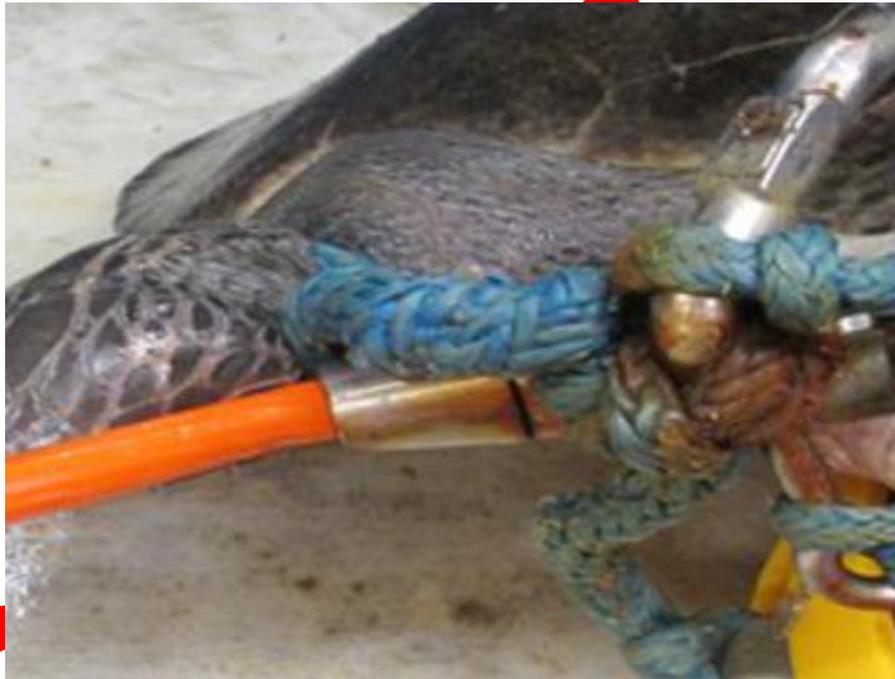
To date; Eight (8) Olive Ridley Turtles have been entangled since 11 July 2014. These occurred during the acquisition of Seismic data along the coast of Gabon under contract with TOTAL Gabon. The turtles have been caught by their front flipper in every incident; the flippers are becoming entangled with the node lanyard that secures the node to the deployment/recovery line. The turtles have been confirmed deceased during each incident.

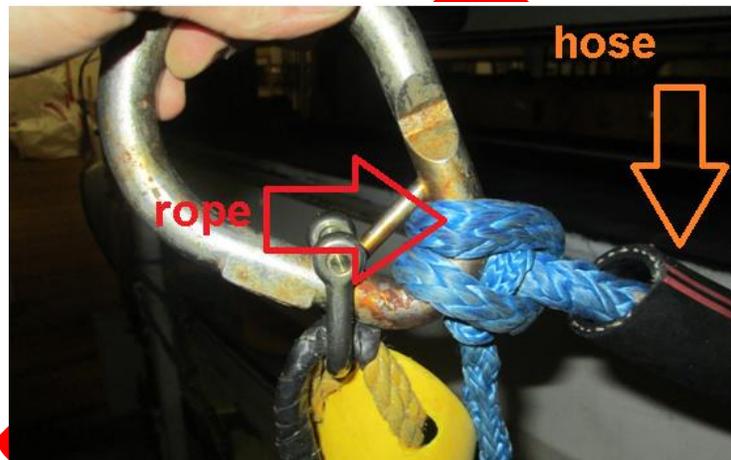
### 5.1. Hose Used to Cover the Rope Lanyards

The use of 0.75" rubber hose has been installed over the node lanyard on about 600 plus nodes of the most recently deployed receiver line (1488). This is the preferred method as it produces the best results to stiffen the rope and provide the lanyard with just enough flexibility to achieve its purpose. If this method proves successful and does not affect data quality, about 12-14" of 3.4" inside diameter hose will be added to each node lanyard.

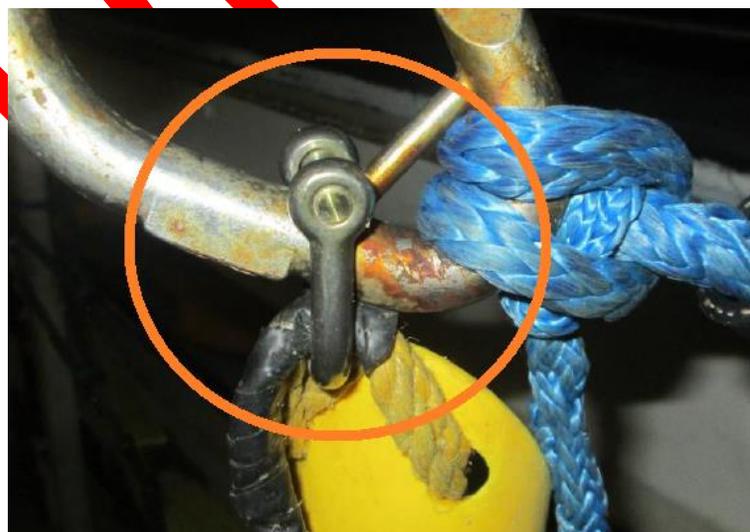
### 5.2 Acoustic Transponder Lanyard Removed

The transponder's lanyards have been removed and are now being shackled directly to the pear links. This eliminates the possibility of the turtles to become entangled in the manner. The transponder is being connected directly to the pear link.

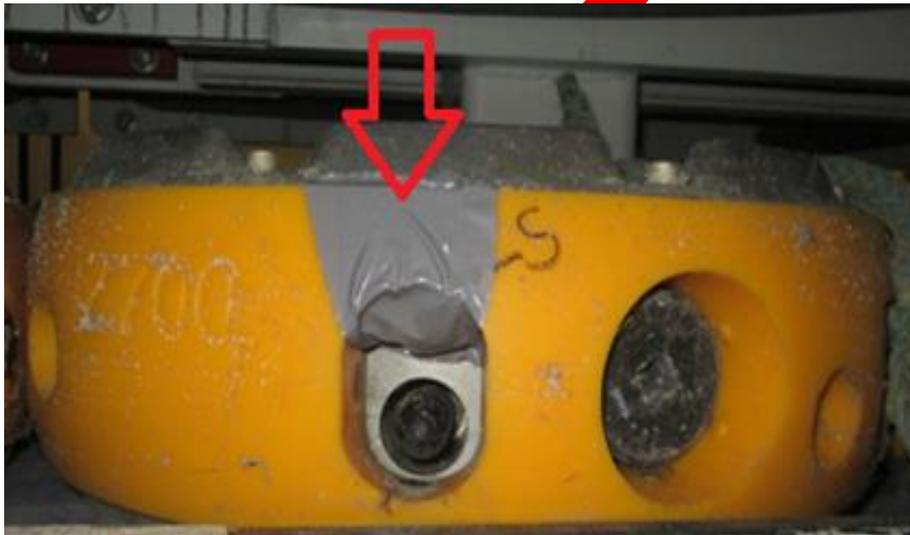
### 5.3. Covering the LED Lights

The LED indication light on the nodes has been covered in an attempt to mitigate the possibility this is attracting the turtles. This was accomplished during the deployment of receiver line 1488.

This was further mitigated by the Fairfield Nodal engineering team generating a new software command that allows the LED light to be extinguished before deployment and remaining off during the time on the seabed. This also removed the need for the taping over LED's done to the nodes previously.

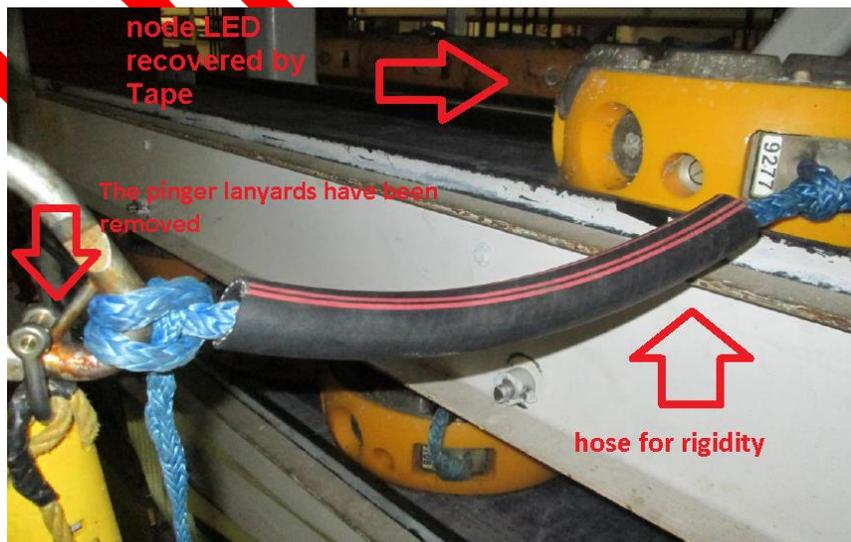
### 6. Combination of the three improvements

FFN team is preparing the next line using the combination of these three correctives actions

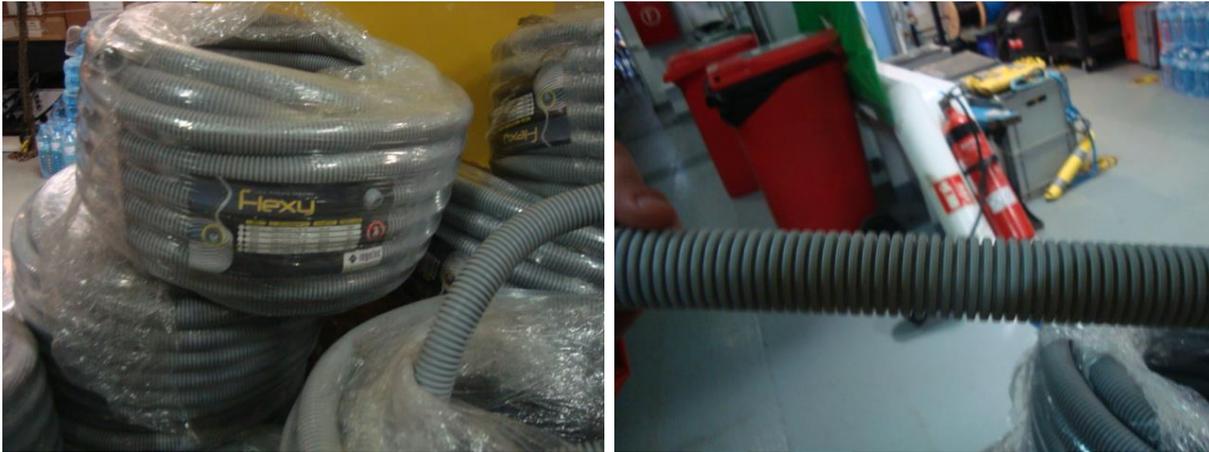
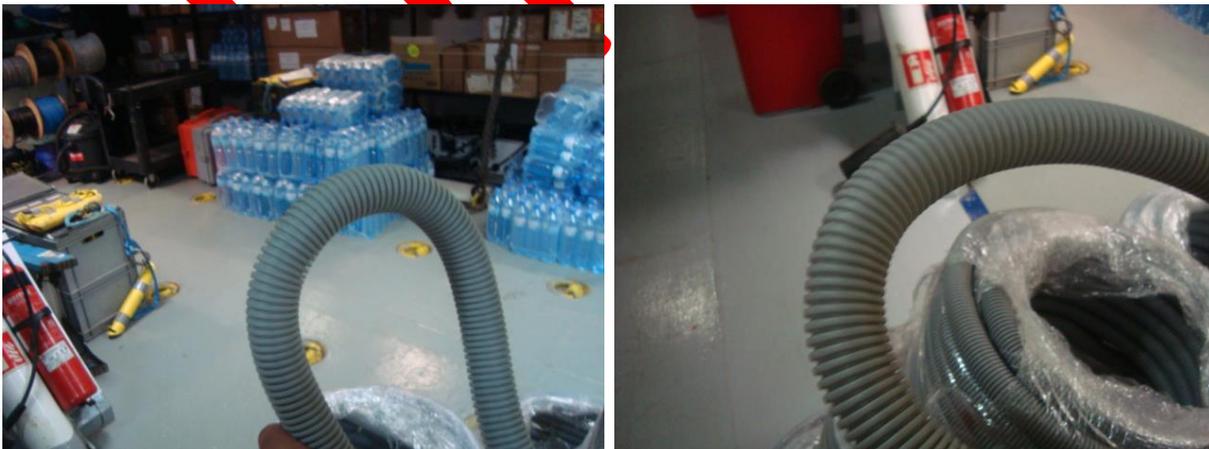
After consultation with specialists we decide to use another material lighter, smart and with good resistance to a lot of external factors. We found this material in Libreville. It's an electrical hose for isolation

- Material polyolefin
- hose insulator, isolant, flexed ,no flames propagator are
- $\varnothing$  external Max 32mm
- $\varnothing$  internal Mini 23,1mm
- Maximum bend radius 96 Degrees
- Swat resistivity 750 Newton
- Impact strength 6j

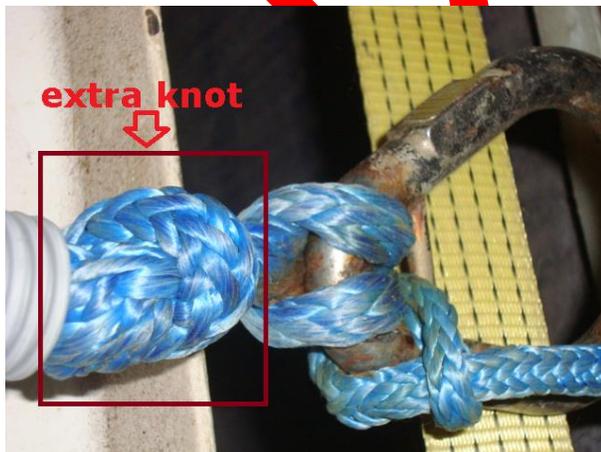
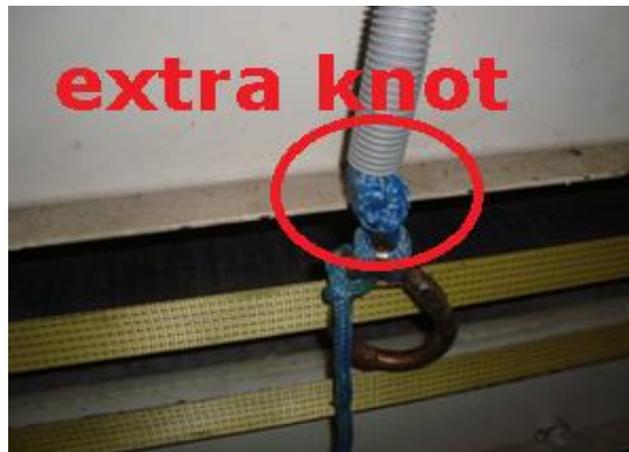
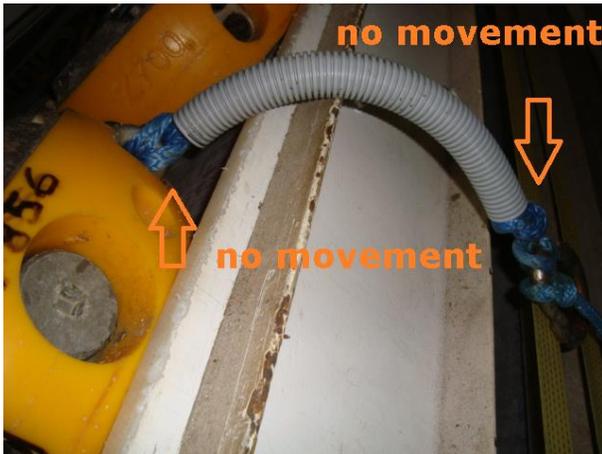
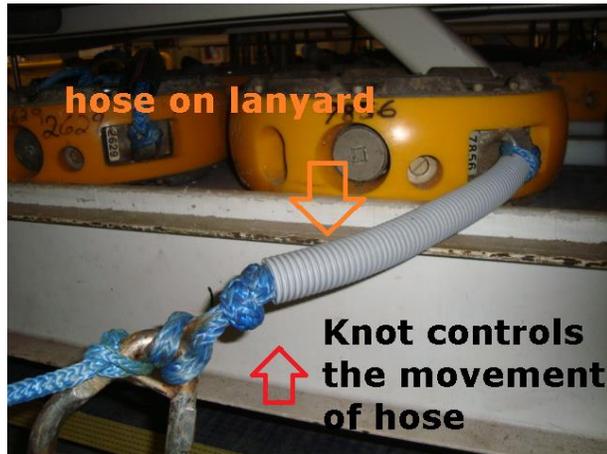
**7.4. Preparation of the new lanyards**

The lanyard with 12 inches length is covered by the grey hose. If necessary we do 1 knot for avoid any movement

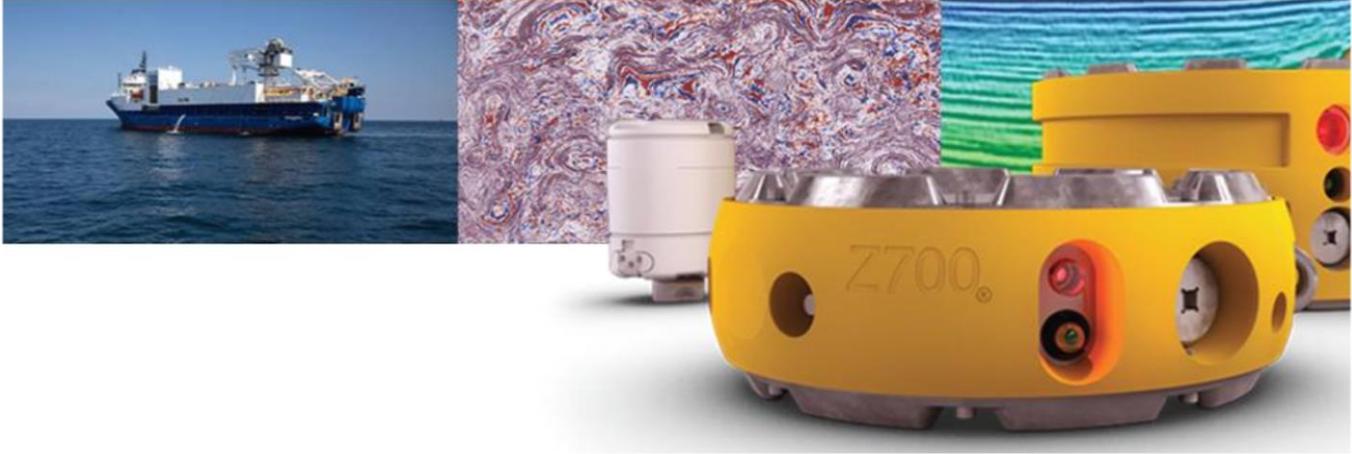
Control, Black Hydraulic Tube, Grey Electrical Conduit

The image block contains a collage of four distinct visual elements. On the left is a photograph of a large blue and white offshore supply vessel on the open sea. To its right is a square area with a complex, multi-colored abstract pattern resembling a marbled or wood-grain texture. Further right is a horizontal strip showing a green and blue wave pattern. In the foreground, centered and slightly to the right, is a yellow cylindrical geophone component with the text 'Z700' embossed on it. The component has several circular ports and a red indicator light.

- The geophone data is the best for analysis of mechanical noise as it does not require fluid coupling to be observed.
- Every channel has a floor amplitude and some anomalies. The anomalies are much higher amplitude with the original lanyard. I suspect that the noise is coming from motion of the connector link which is apparently free to move more with the soft lanyard by itself.

- Both of the shell material methods significantly reduce the magnitude of the amplitude anomalies.
- Both were significantly better than the current naked lanyard rope both in consistency and amplitude of noise floor and in reduction and less severity of the anomalous amplitudes.
- I would recommend either method from the point of view of noise characteristics

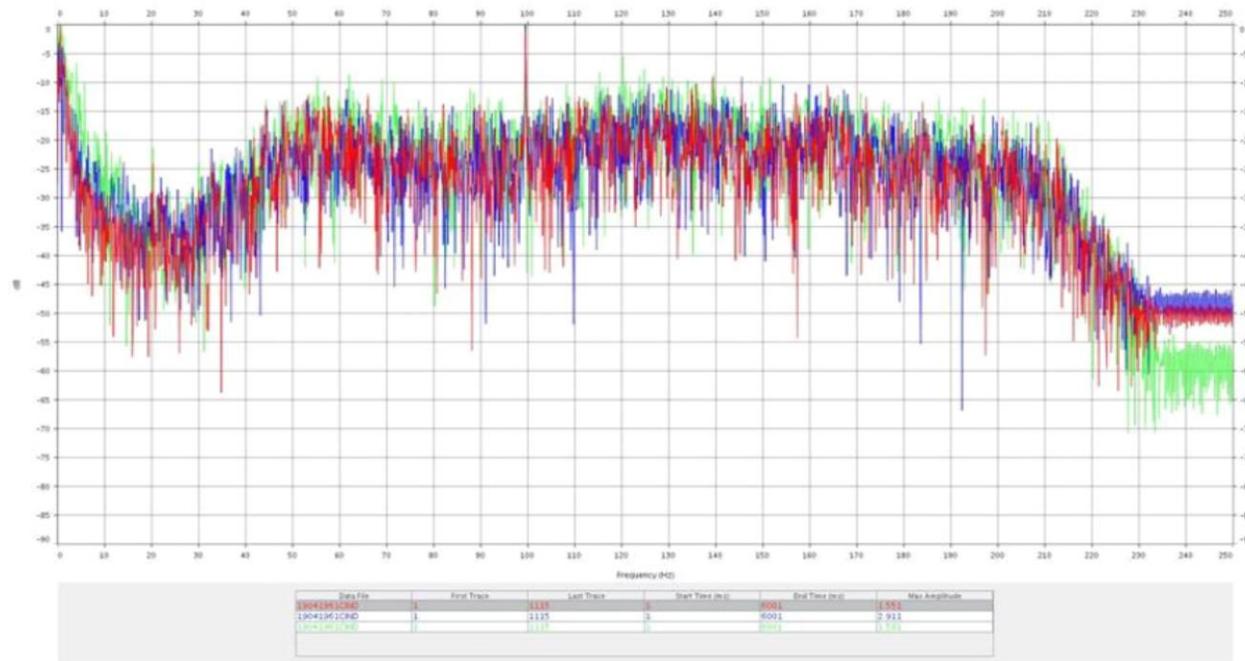
## Control (Dyneema) – C1

- The following graphs are the spectra for the entire test deployment of the turtle mitigation lanyards.
- Each of the three colors depict one of the three nodes with that specific test.
